Confidential Inspection Report
● Tennis Avenue
Ambler, PA 19002

Home Inspection Report Summary for:

Performed: November 28, 2009

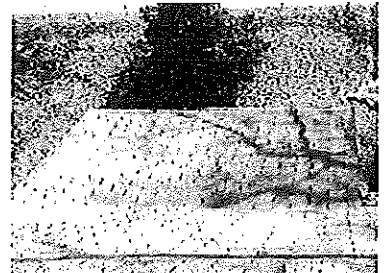
ROOF CONDITION
Roofing materials appear to be in serviceable condition at time of inspection.
Roofing materials show signs of age and wear with, granule loss.

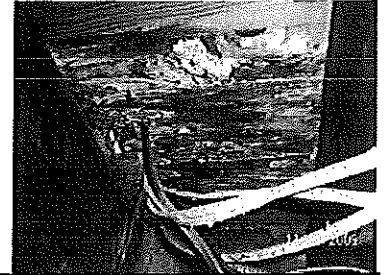
Serviceable where visible **EXCEPT:** Moisture staining is present, in the crawlspace beneath the 1st floor bathroom. Moisture stains tested dry with the moisture meter at the time of the inspection. All water fixtures were operated/run and the toilet was flushed several time immediately before inspection of subfloor. (Maint.)(Monitor)

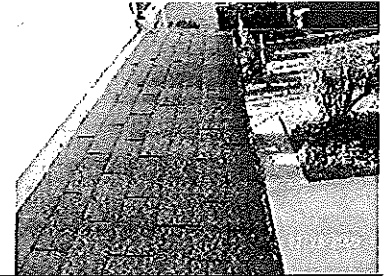
Roofing materials are in serviceable condition at time of inspection.

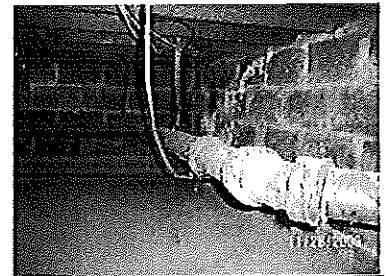
Serviceable were visible. No leaks or signs of leaking at the time of the inspection. The cast iron drain pipe is rusted. No leaking observed. Recommend repair/replacement to prevent future leaking. (Maint)(Monitor)

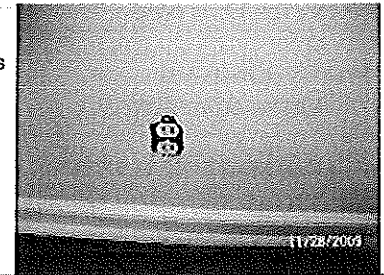
A representative sampling of switches and outlets was tested. As a whole, outlets and switches throughout the house are in serviceable condition. Missing cover plate viewed in the living room. Client should install face plates on all outlets and switches, where missing, to prevent shock. (Safety)

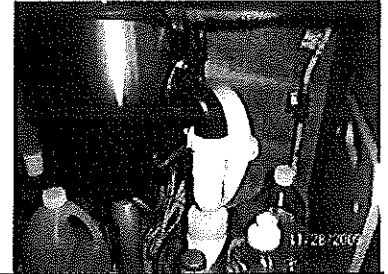
Serviceable. No leaks observed at the time of the inspection.
Homeowner storage has restricted the viewing below the sink area. (Verify)

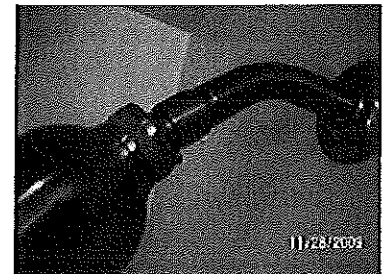
Serviceable, EXCEPT there is a leak between the shower head and the shower head arm. (Maint)
